REPORT DOCUMENTATION PAGE		READ INSTRUCTIONS BEFORE COMPLETING FORM
1. REPORT NUMBER	2. GOVT ACCESSION NO.	3. RECIPIENT'S CATALOG NUMBER
	4D-A109786	
4. TITLE (and Subtitle) Phase I Inspection Report Beebe Lake Dam Oswego River Basin, Tompkins County, NY Inventory No. 394		5. TYPE OF REPORT & PERIOD COVERED Phase I Inspection Report National Dam Safety Program

PHASE I INSPECTION REPORT
NATIONAL DAM SAFETY PROGRAM
BEEBE LAKE DAM
N.Y. 394
DEC I.D. NO. 75A-691
OSWEGO RIVER BASIN
THOMPkins COUNTY, NEW YORK

Name of Dam:	Beebe Lake Dam N.Y. 394
State Located:	New York
County Located:	Thompkins
Stream:	Fall Creek
Date of Inspection:	March 26, 1981 and June 3, 1981

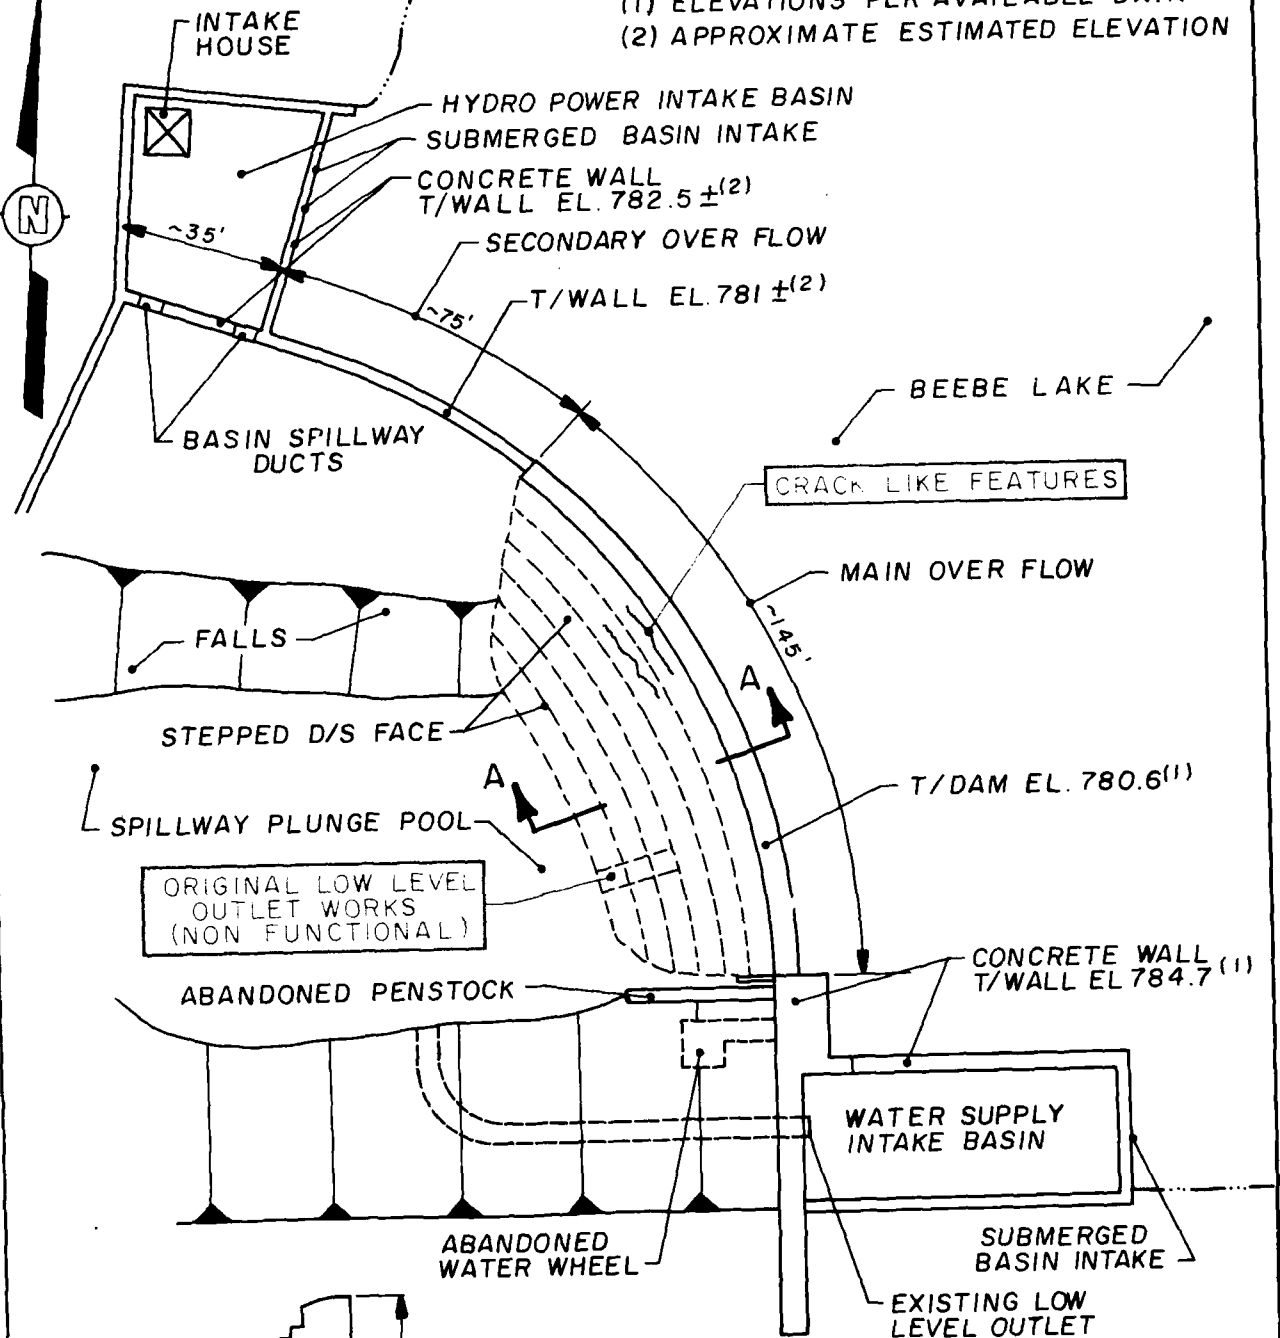
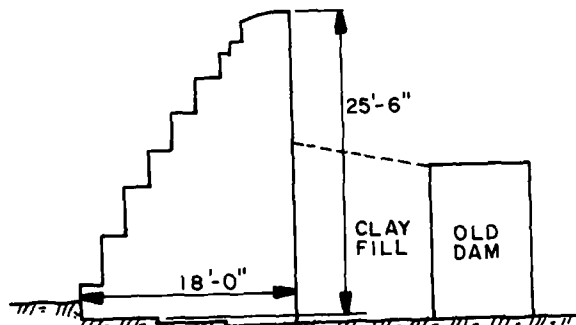
SECTION A-A

As noted before, very limited information is available on the design and construction of the dam. Sketches in Plate 2 illustrate the plan view and typical cross section of the main nonoverflow section as derived from the available information. As shown in Plate 2, the dam was constructed immediately downstream from an existing masonry dam and the space between the existing and the new dam was filled with clay. The main overflow section is approximately triangular in cross section, with a base width of 18 feet and a structural height of 26 feet at the maximum section. The downstream face was stepped, apparently for the purpose of dissipating the energy of falling water. References were found to indicate that a cutoff trench was excavated at the base of the main embankment. However, no reference was found to indicate the extent and nature of the cutoff trench.

Some minor structural cracks were observed on the downstream side of the nonoverflow section near the left abutment. Plate 2 illustrates the locations of these observations. To the extent visible through falling water, horizontal crack-like features were observed on the downstream face of the main dam. It is possible that deteriorating concrete at horizontal construction joints could be causing this appearance. It is considered advisable that the downstream face of the dam be more closely inspected during low flow periods to assess the nature of these features.
